MEETING – AGENDA –

Performance and Monitoring Committee

9.7 ŌMOKOROA CYCLEWAY SAFETY REPORT

Council has procured a post construction safety audit of the Ōmokoroa to Tauranga Cycleway. The audit team follow a standard procedure to identify risks for users of the service and risks for Council's consideration and where possible, mitigation. The safety audit was a condition of funding.

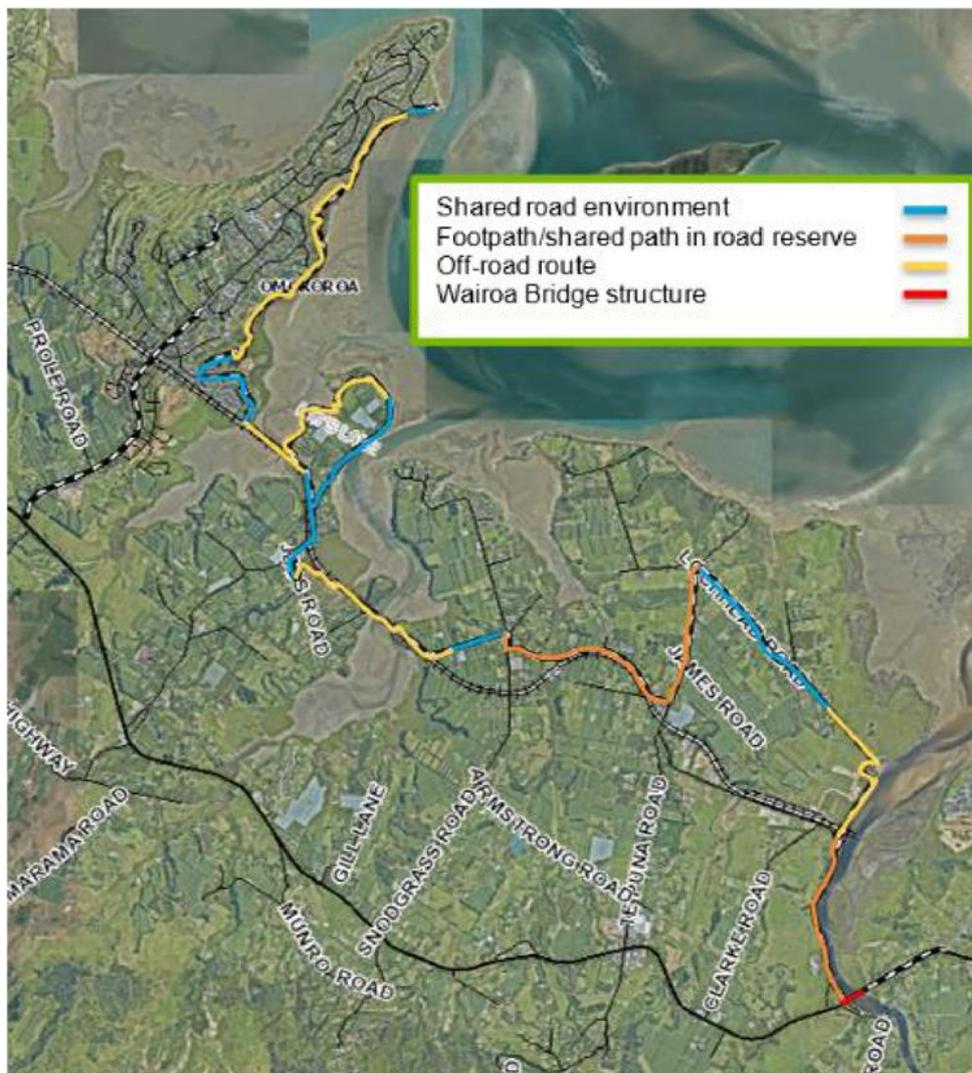
Figure 2: Overall route with facility types

The cycle route currently starts at the Wairoa River Bridge with signage indicating that the route is a shared path. There is a crossing from the bridge to access the route running along the riverbank. The route changes from a concrete/sealed surface to a gravel route at the rail underpass along Te Puna Station Road. This section of the route comprises of shared facilities for pedestrians and cyclists and a separate bridleway which has a level difference to the shared section. The gravel route connects to Lochhead Road with no indication that the carriageway is a shared space. As the route continues along Lochhead Road onto Te Puna Road, the facility becomes a narrow footpath and is it not clear if the facility is for pedestrians with cyclists using the carriageway, or a shared path. The uncertainty carries through Borell Road and Snodgrass Road. The remainder of the route is mostly off road with limited sections shared on carriageways as shown in Figure 2.

It is unclear on some sections where the user should be and observations of users during the field audit reinforced this, with some cycling on the off-road path while others used the carriageway. On sections of shared use road where the posted speed limit is above 60km/h, should a vulnerable user be hit by a vehicle travelling at speed, there is risk of death or serious injury.

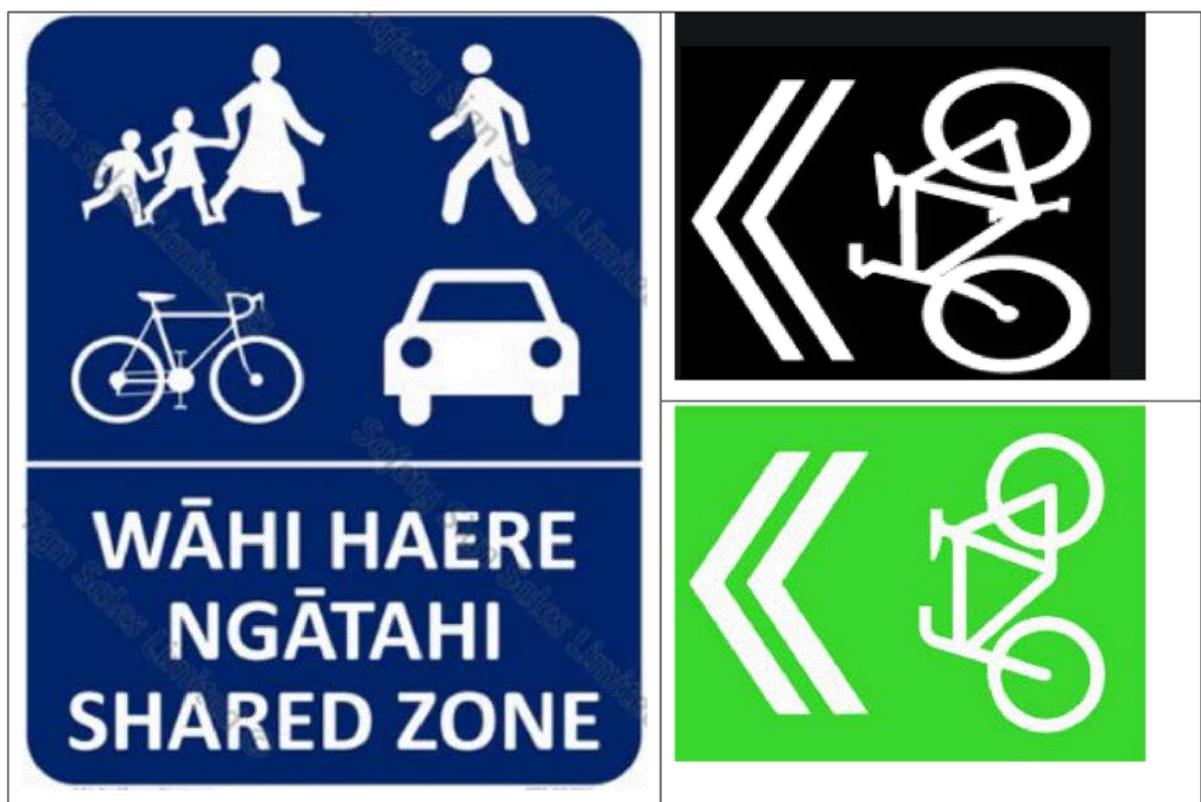
Example signs and markings (sharrows) are provided below. Where horse riders commonly share the carriageway as well, a horse-riding symbol should be added to the sign. Options exist to include Te Reo Maori. Hamilton City Council are using sharrows on a green background to further highlight cycle use.

- Reduce the speed limit where users share the carriageway. In the interim include a speed advisory sign in conjunction with the shared use sign recommended below;

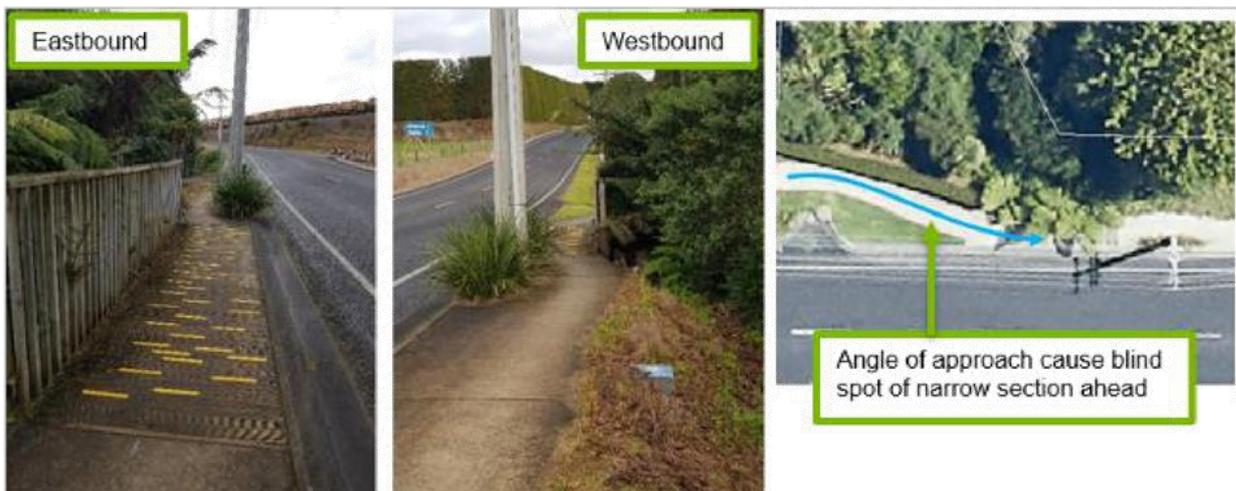
Figure 5: Culvert narrowing along Borell Road

A narrow section between a culvert and service pole is located on Borell Road which requires careful navigation. Both approaches to this restriction are downhill, but the safety risk traveling eastbound is higher as this is the steepest approach and the path is angled causing a blind spot at the narrow section on the opposite side of the culvert as shown in Figure 5.

- Increase the width on the narrow sections of the route, and provide localised widening along the route to allow users to give way to others by moving aside;
- Investigate options to widen the timber section and move the fence to remove the visibility restriction.

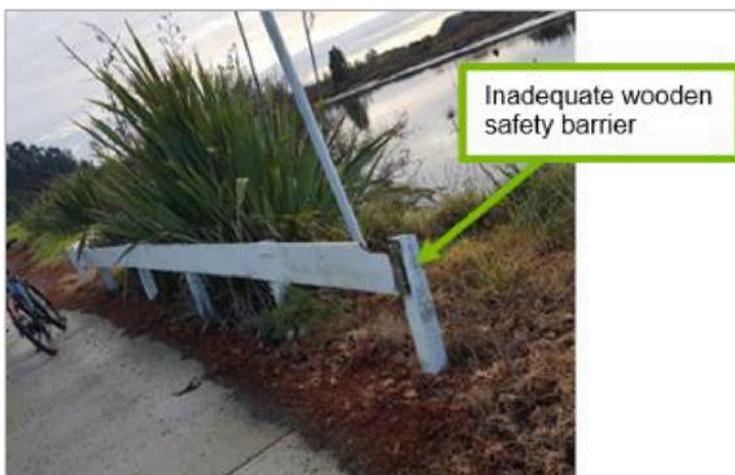
Figure 9: Inadequate wooden sight rail

The white painted wooden sight rails are not adequate for a shared path facility as shown in Figure 9. The risk remains for a cyclist to fall over the wooden barrier. The barrier does not reduce the risk of injury at the drop-offs. If it is there as a visual warning to drivers exiting Waipuna Hospice, to not drive straight across and into the river, it should be replaced with the appropriate chevron board.

- Provide reflectorised delineation on the leading edge of fences and barriers that are adjacent to the path;
- Replace wooden sight rail opposite Waipuna Hospice with appropriate barrier to the drop off and install a chevron board for traffic exiting the Hospice; and
- Provide caps on all waratah fences.

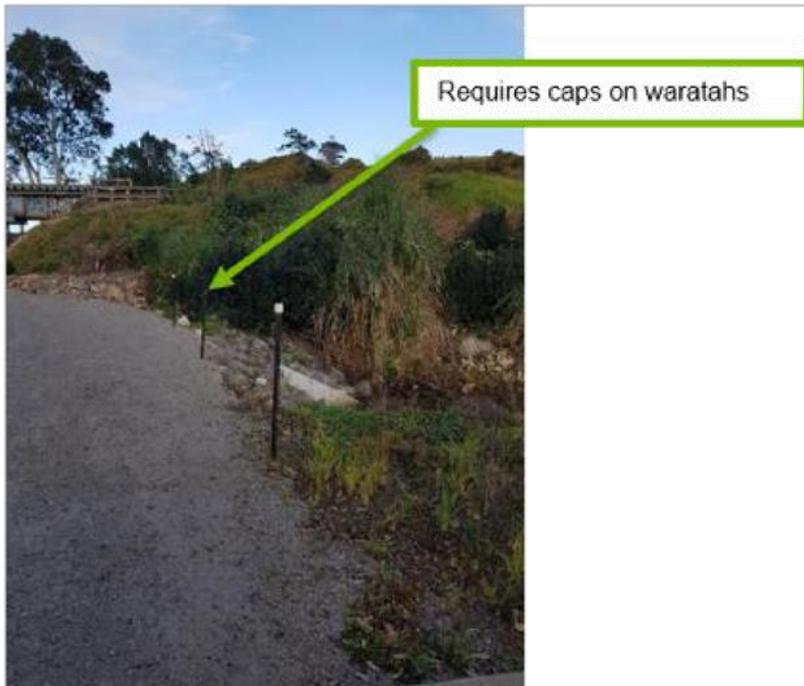
Figure 10: Waratah fence near Te Puna Pony Club

Some of the off-road sections contain waratah fences without caps as shown in Figure 10. This can be a safety risk as the steel rods and wires can cause injuries in an incident. There are locations where only one side of the path has a waratah fence with the same hazard being exposed on the opposite side. These fences may be temporary but remain a hazard.

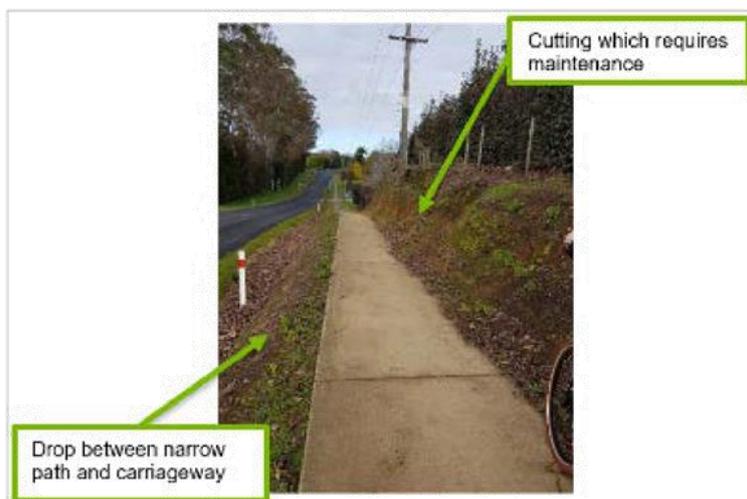
Figure 11: Cutting on Te Puna Road

Te Puna Road has a narrow-shared path as referred to in Section 2.1.2. The shared path passes through a cutting with collection of gravel and leaves, reducing the allowable width as shown in Figure 11. The collection of gravel and leaves also adds to the risk of slipping and falling along this section of road, especially when it is wet.

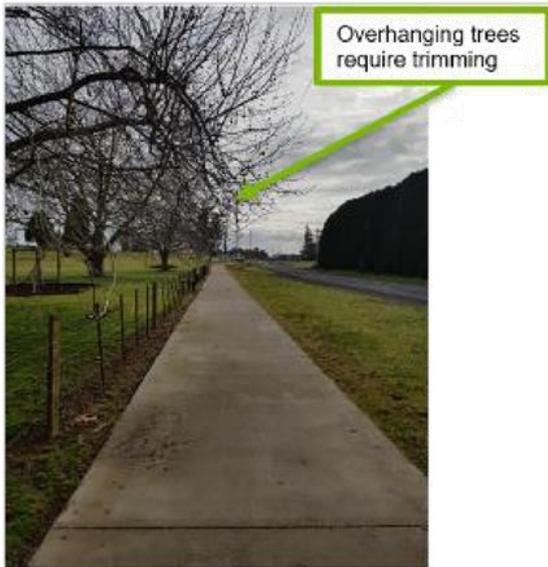
Figure 12: Trees overhanging the shared path along Te Puna Road

The section of Te Puna Road beside the rugby club currently has trees overhanging the shared path with the branches hanging at cyclist's head height, as shown in Figure 12. The branches could cause injuries to cyclists.

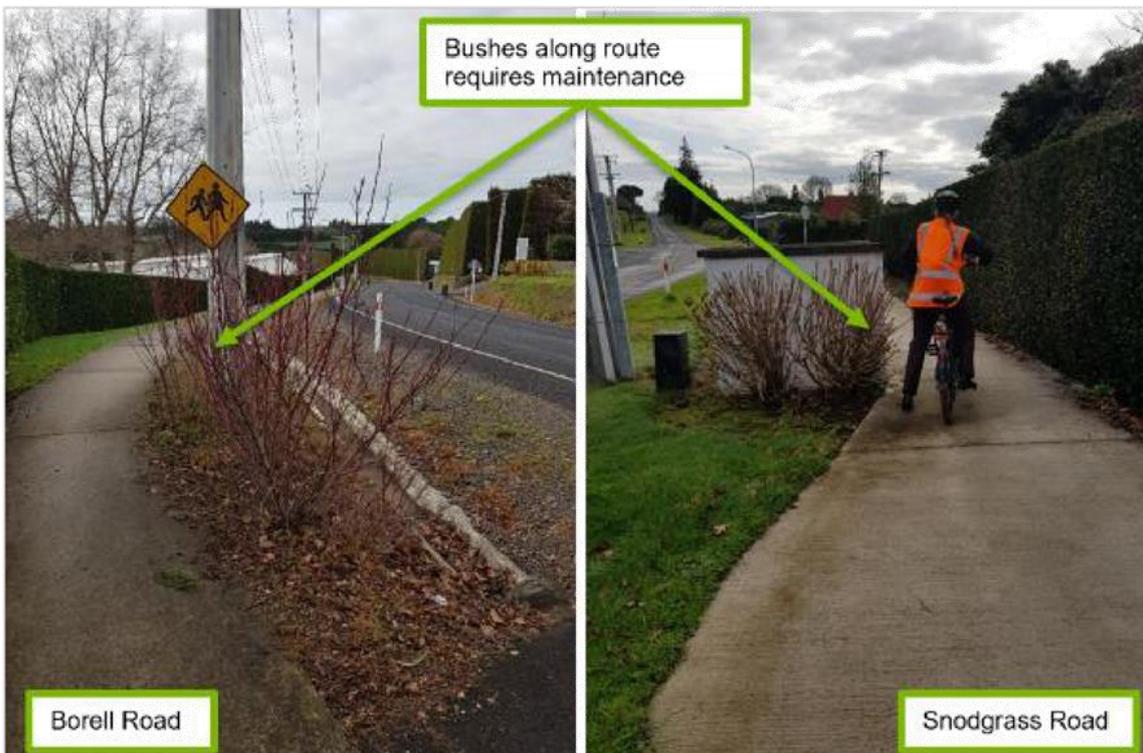
Figure 13: Bushes along Borell Road and Snodgrass Road

The cycle route along Borell Road and Snodgrass Road have sections running of the path beside shelter belts. Overgrown shelter belts reduce the width of the facility as well as increase the risk of bikes getting caught in branches which may cause a crash. There are also some bushes, such as the rose bushes shown in Figure 13, which require trimming to clear the bushes from the route which may cause injury.

- Ensure that ongoing maintenance activities are undertaken outside of peak use times (both footpath and road peaks) to minimise diversion impacts on users when work is being carried out; and
- Undertake regular vegetation control along the shared route.

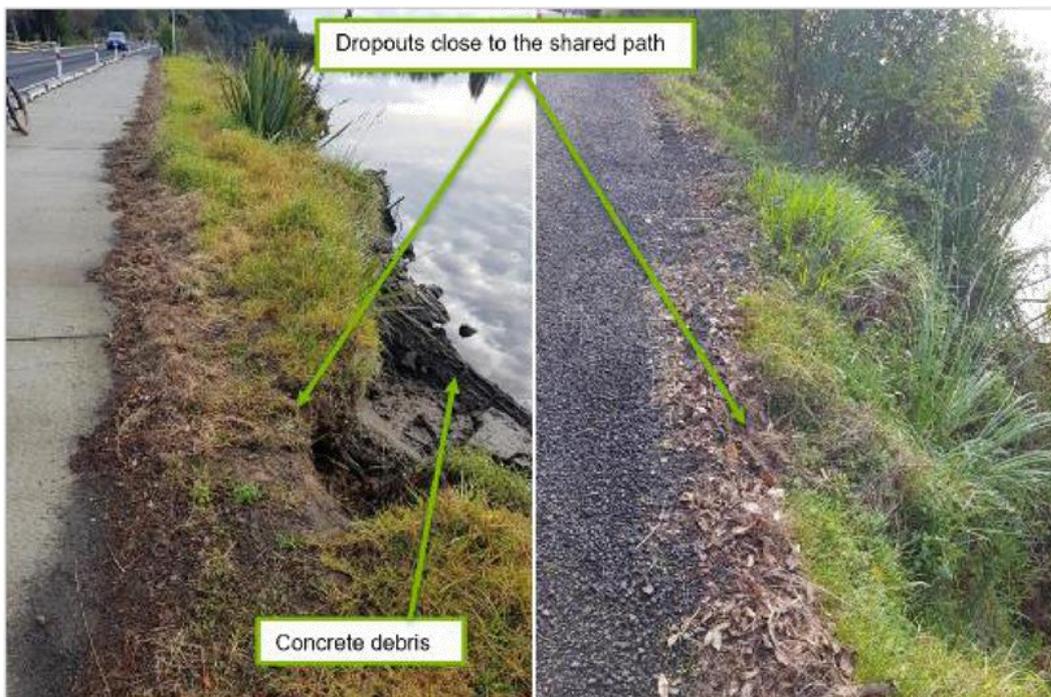
Figure 15: Dropouts close to the cycle route

There were three locations noted by the RSAT on Te Puna Station Road where dropouts have occurred close the cycle route as shown in Figure 15. (There may be others.) The dropouts appear recent with the one having concrete in it which might have been structural support for that specific section of road. The drop-offs close to the edge of the cycleway facility require protection to minimise the risk of path users falling to the river below.

- Provide adequate safety measures to protect path users from risk of falling into the river;
- Investigate and repair the dropouts to maintain the long-term stability of the route.

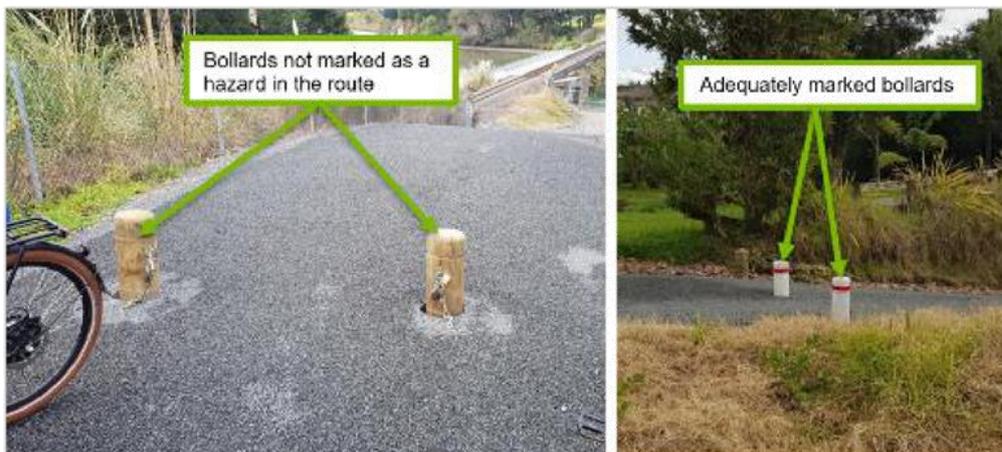
Figure 16: Bollards along cycle route

Bollards are placed along the route where vehicles can access the cycle route, usually where the route changes facility type (for instance road to off-road) or at points where vehicles are expected such as the parking areas and access for maintenance vehicles. In most of the instances the centre bollards located in the cycleway are not adequately marked, as shown in Figure 16, which is necessary to highlight the hazard to the facility users thus reducing the risk of cyclists impacting the bollard and causing injury.

- Provide consistent warning markings on all bollards along the route;
- Where possible and operations permit, remove bollard hazards from the route.

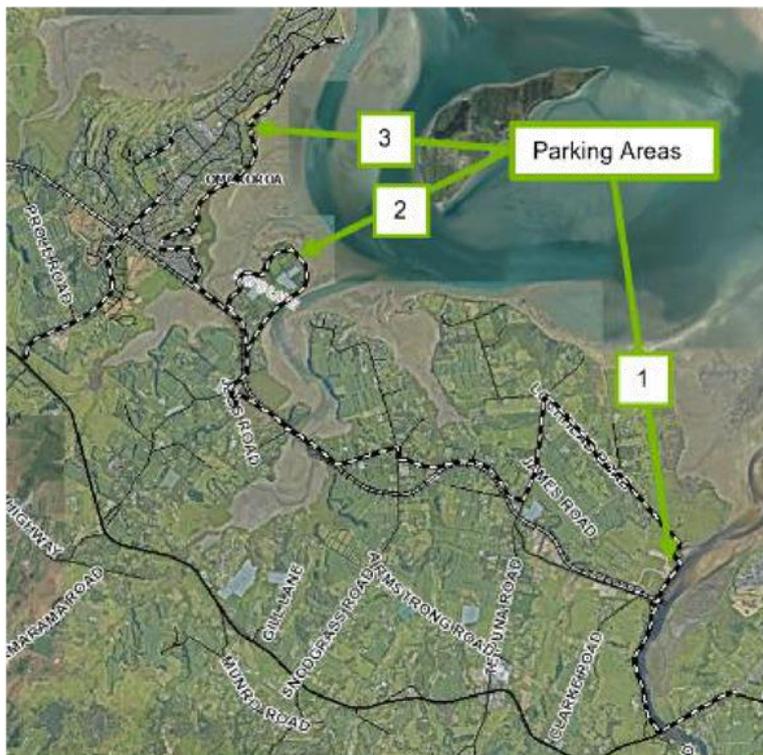
Figure 17: Location of car parks along route (WBoPDC Mapi)

There are a total of three formal car parks along the route where recreational users can park vehicles and access the route as shown in Figure 17 and Figure 18. Car park 1 below, is beside the Wairoa River on Te Puna Road and the shared route runs between the car park and the river.

- Provide by-pass cycle route at parking areas; and
- Delineate the locations where cyclists are meant to enter and exit to cross car parks and ensure that these locations are wide enough for safe cycle use and that the safe route through the car parks is clearly marked. To use the public toilets at Huhurua Harbour Park, cyclists will need to cross the car park.

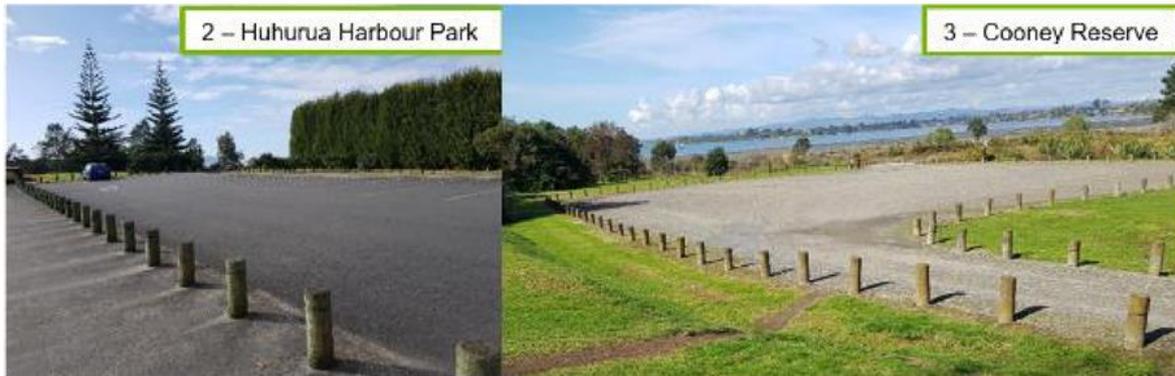
Figure 18: Layout of car parks

At car parks 2 and 3, (Huhurua Harbour Park and Cooney Reserve) there is no route around the parking area requiring users to travel through the car park. When car park use is high and vehicles are manoeuvring, this poses a risk to cyclists with potential conflict. Providing a route around the car parks will reduce the risk of users being hit by vehicles as well as reducing the risk of cyclists hitting bollards as they enter or exit the car park.

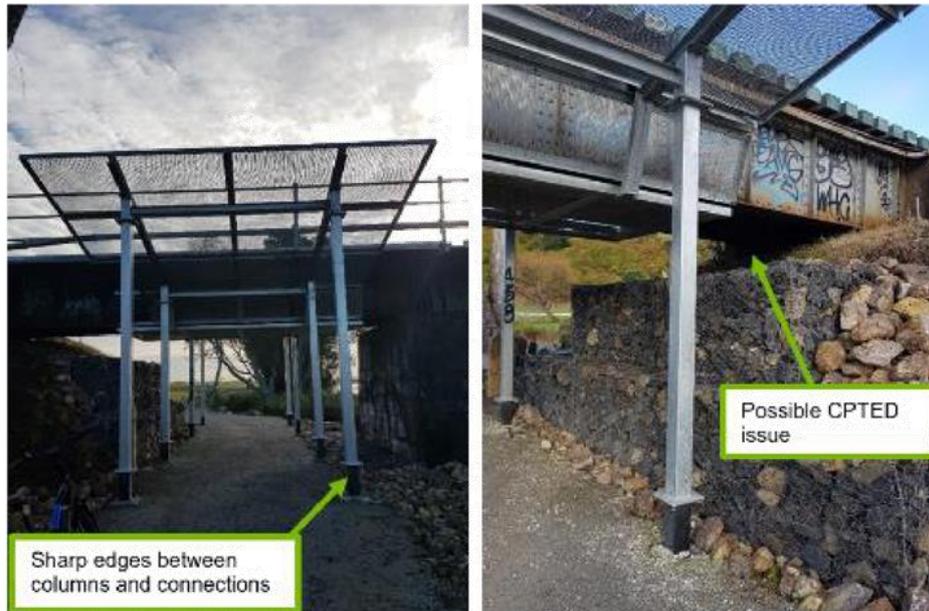
Figure 19: Rail underpass at Te Puna Station Road

There are two rail underpasses along the cycle route. The underpass close to Te Puna Station Road has columns with a short connecting base. The fixing plate between the column and the base has protruding edges which are the height of a cyclist’s legs as shown in Figure 19. There is a risk that cyclists passing one another at the underpass might sustain an injury if their leg or pedal impacts the column. The columns also require reflectorised warning strips along the leading edges to highlighting the hazard as has been done at the Jess Road underpass, providing consistency in hazard marking along the route. There is also a gap between the railway bridge bed and the bridge structure which could be used as a hideout which is a CPTED issue.

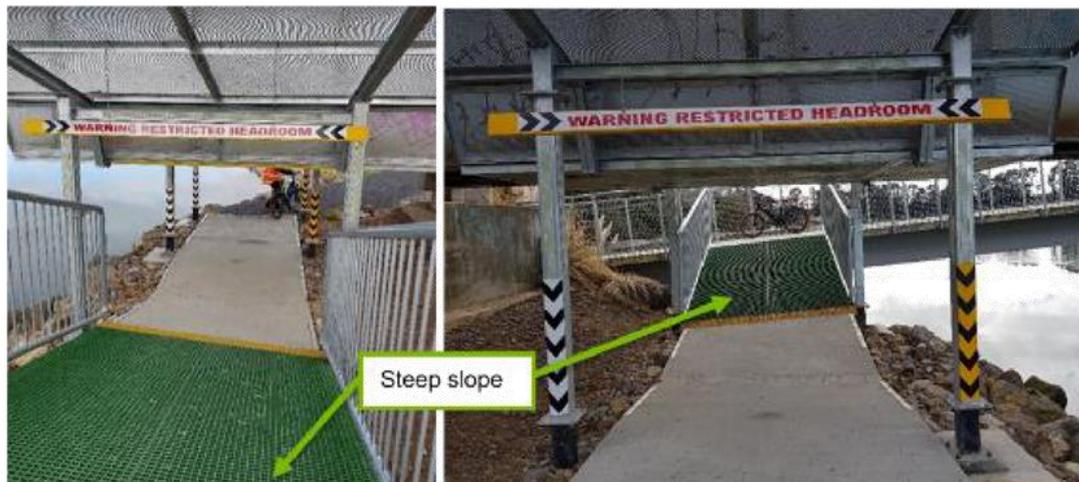
Figure 20: Rail underpass at Jess Road

The second underpass close to Jess Road has adequate warning signage for the columns and height restriction warnings as shown in Figure 20. The transition under the bridge presents risks of loss of control and the potential to hit one's head.

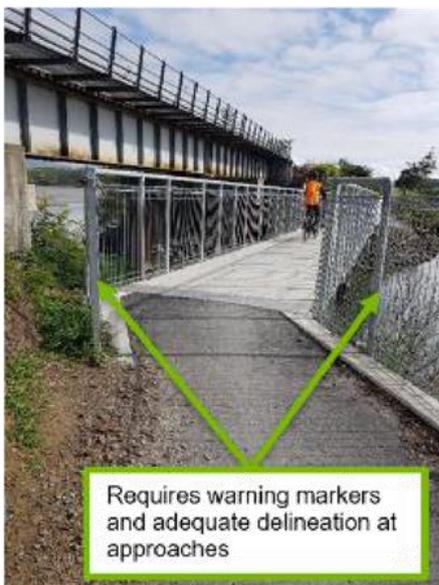
Figure 21: Bridge railing without adequate hazard markings

There are various bridges along the cycle route with some being large steel structures next to rail bridges and some being smaller wooden structures along the boardwalk near Omokoroa. All the bridges contain steel or timber railings to eliminate the risk of cyclists falling off the bridge. The railings on either side of the bridges need adequate reflective warning strips on the leading edges to highlight the hazard and to reduce the risk of cyclist hitting the railings as they enter the bridge as shown in Figure 21.

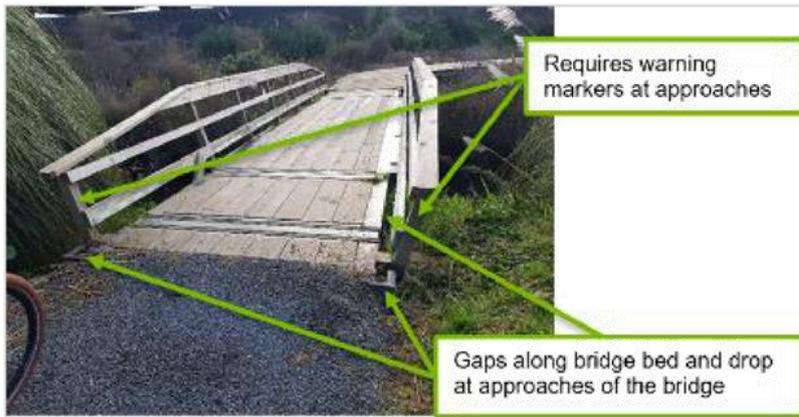
Figure 22: Bridge close to underpass at Te Puna Station Road

There is a wooden and steel combination bridge as the cycle route approaches the rail underpass at Te Puna Station Road as shown in Figure 22. The bridge has a wooden deck which may become slippery if wet or during winter mornings with dew or frost on the deck. The bridge bed has gaps along the edges which are large enough for a bike's wheel to get caught in if a cyclist is pushed to the side for any reason which may result in injuries to cyclists. The surface change from gravel to the bridge's wooden deck has steel protruding either side of the bridge, which also presents a hazard.

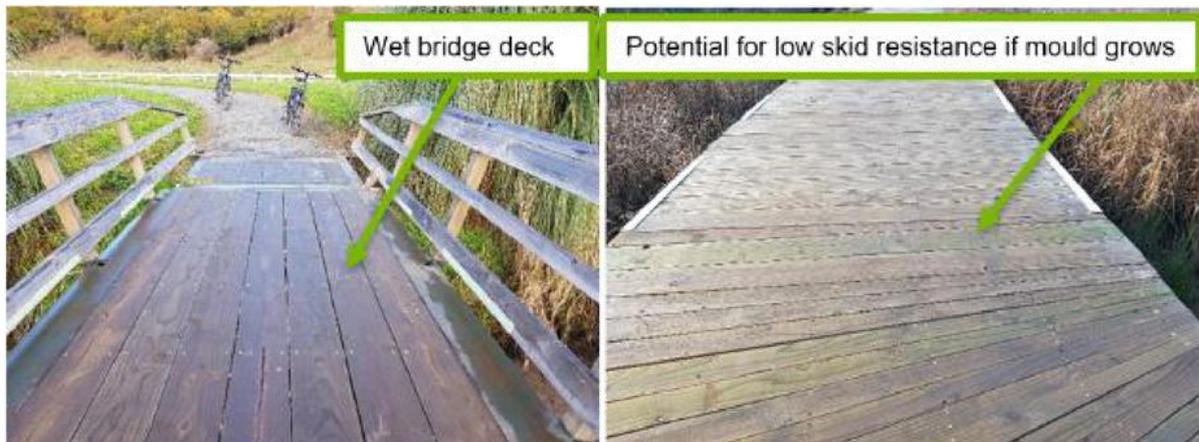
Figure 23: Wet bridge deck and possible mould growth

There is a risk that mould will grow on the wooden decks reducing the skid resistance which may cause injuries if cyclists slip and fall while travelling along the bridge and boardwalk, as shown in Figure 23.

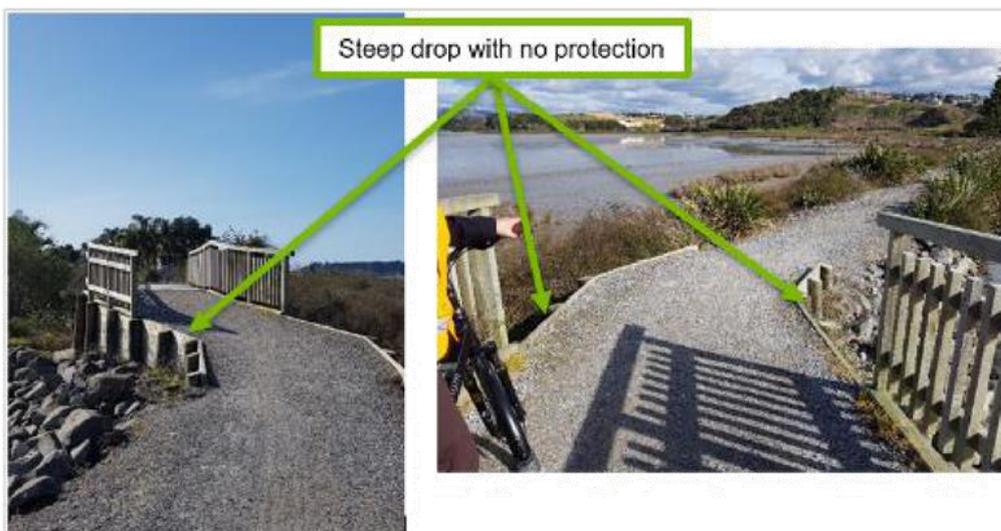
Figure 24: Wooden bridge with steep drop off at boardwalk

The wooden bridge on the boardwalk section of the route close to Omokoroa requires additional barriers as shown in Figure 24. Traveling westbound requires a cyclist to exit the bridge on a bend while the surface changes from the wooden bridge deck to gravel with steep drops and rocks on either side of the bridge. There is a risk of cyclists, especially inexperienced cyclists, being surprised by the changing conditions and the alignment cause them to drop off the edge of the bridge onto the rocks. Figure 24 show the limited sight distance over the bridge due to the crest curve, with the upcoming horizontal alignment and drop off hazard hidden from view.

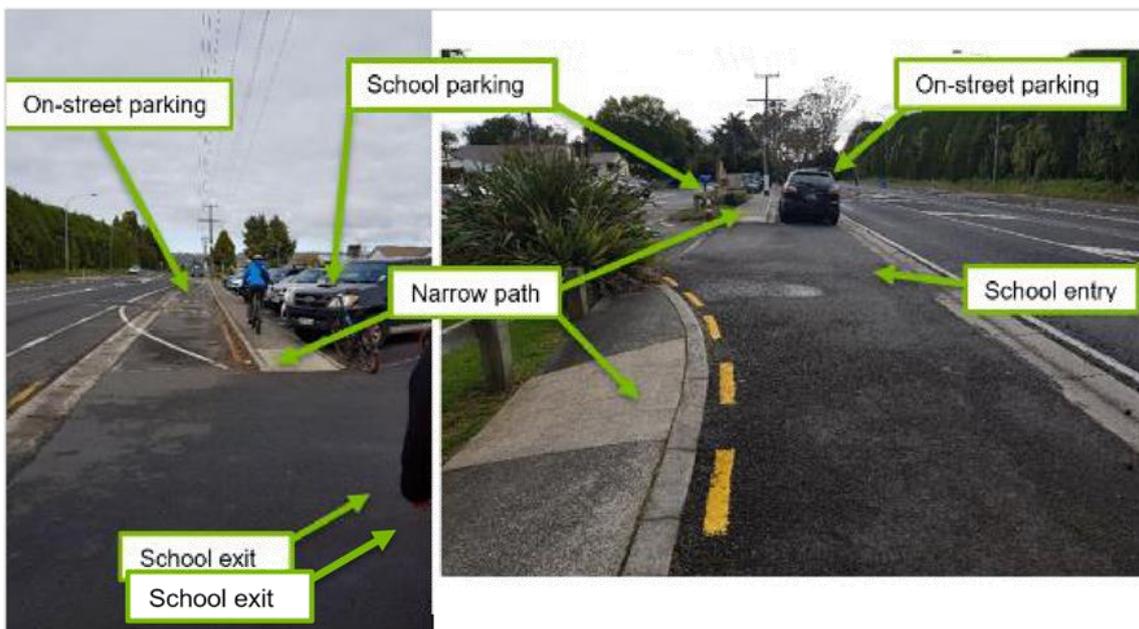
Figure 26: Interface at Te Puna School

This will be less of an issue during weekends when recreational cyclists will be travelling through this section encountering an empty car park with ample space to safely travel through. During weekdays during school term, cars are parked outside the school leaving a narrow section between the on-street and on-site car parking, open to travel on. Cyclists can travel through the car park or on the carriageway as an alternative option. During the audit cyclists were observed using the narrow path obstructed by a service pole.

- Improve the interface between Te Puna School and cycle route with the provision of greening on the dedicated route, or
- Provide clear route direction, such as a painted line that users are instructed to follow, similar to that provided at Auckland Airport for pedestrians to walk between the domestic and international terminals;

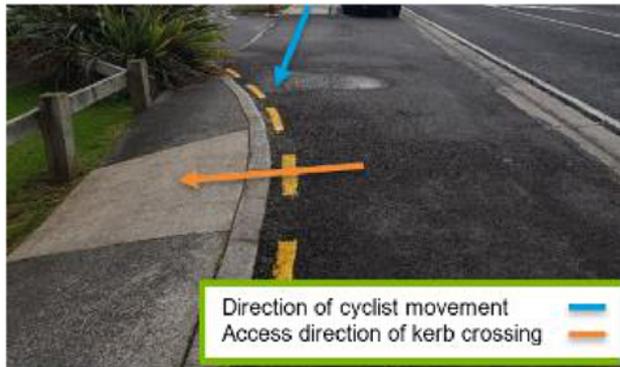
Figure 27: Kerb crossing at Te Puna School

At Te Puna School, an existing kerb crossing to the south of the car park is not aligned with the direction of travel for cyclists (if they are to re-join the off-road path here). The manoeuvre requires cyclists to slow to execute the turn safely. Refer Figure 27. There is a risk that cyclists, especially inexperienced and e-bike users (if going too fast), will not be able to make the turn and may lose control.

- Confirm the intended cycle route and realign the kerb crossing for safe use as required.

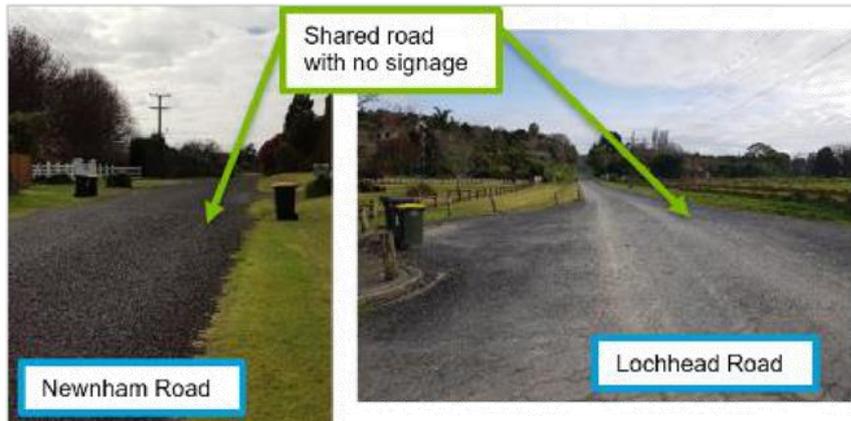
Figure 28: Shared road environment with no signage

Some sections of the route require cyclists to use the carriageway along low volume roads to connect between off-road sections as shown in Figure 28. None of the shared areas adequately warn or provide for a shared road environment. There is a risk of drivers being unaware of the change to a shared road environment and not being vigilant for cyclists, pedestrian and in some cases horse riders.

The risk of an injury crash increases with higher speeds and mixing multiple vulnerable road users with high speed traffic should avoided.

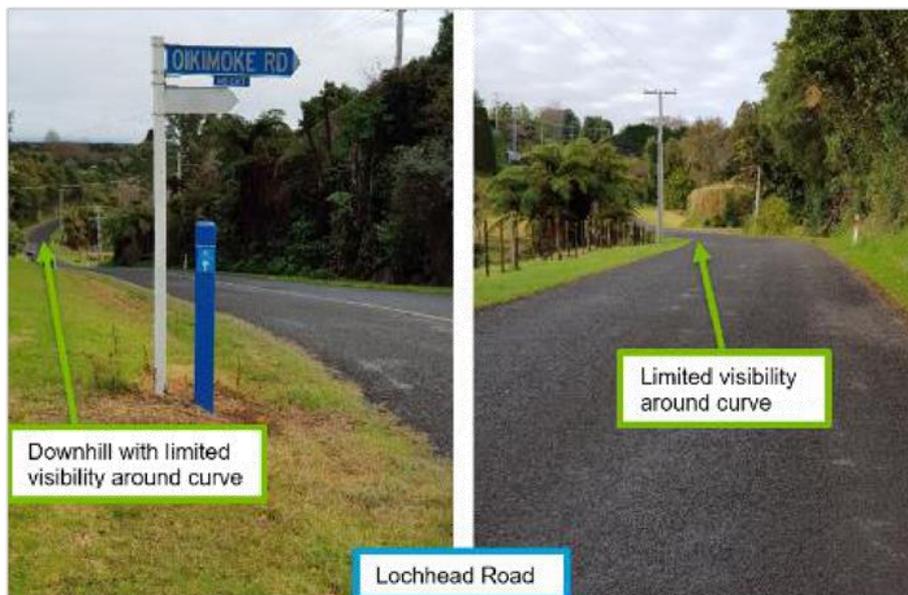
Figure 29: Lochhead Road's downhill section with limited visibility curve

Lochhead Road currently has a posted speed of 70km/h which the RSAT considers unsafe for the shared environment. There is a downhill section along Lochhead Road travelling northbound past Oikimoke Road in which cyclists could achieve high speeds. There is a bend at the end of the downhill section with limited visibility as shown in Figure 29. Approaching drivers may cross over the centre of the road as they travel around the bend. A head on collision could be fatal.

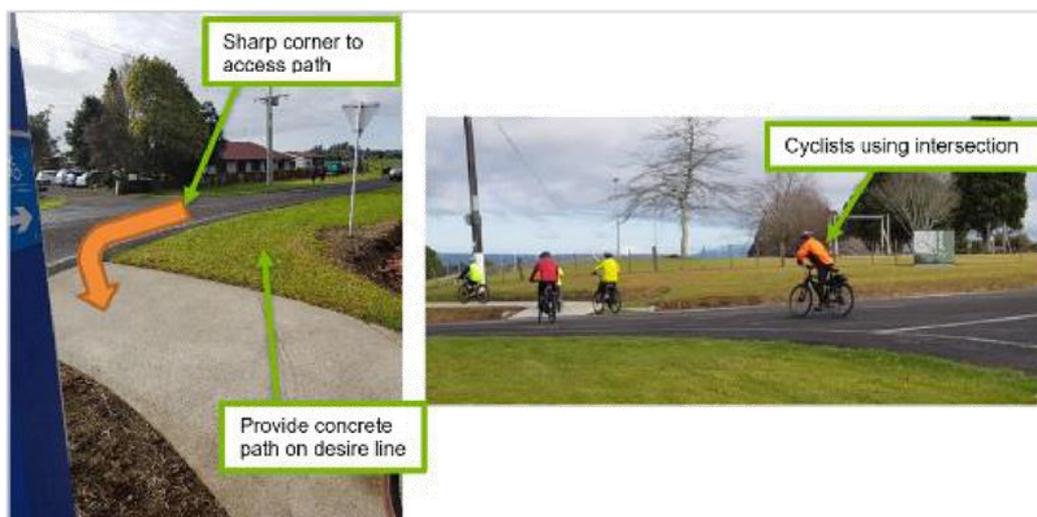
Figure 30: Te Puna Road and Lochhead Road Intersection desire lines

Some cyclists are not following the provided facilities at the intersection but are continuing along Lochhead Road up to the yield and crossing from there onto the facility along Te Puna Road as shown in Figure 30. Staying on Lochhead Road provides better visibility along Tangitu Road and the angle of the concrete path does not encourage users to access the off-road path. The angle is sharp which requires a low speed to manoeuvre from Lochhead Road to the concrete path. This low speed manoeuvring can be difficult for inexperienced cyclists or younger cyclists which may cause them to fall. From the marks on the grass berm it is evident that some users ride across the grass, cutting the corner.

The RSAT is aware that the path is likely constructed as it is to discourage riders heading towards the Wairoa River from entering the carriageway without stopping to check for traffic. Or it may be the intention for cyclists heading for Te Puna Road to stay on the Lochhead Road carriageway. There is nothing signed or marked to indicate the answer to this.

- Consider providing additional concrete path on the desire line from Lochhead Road to Te Puna Road together with path markings to indicate that the additional desire line is for a single direction of travel toward Te Puna Road.

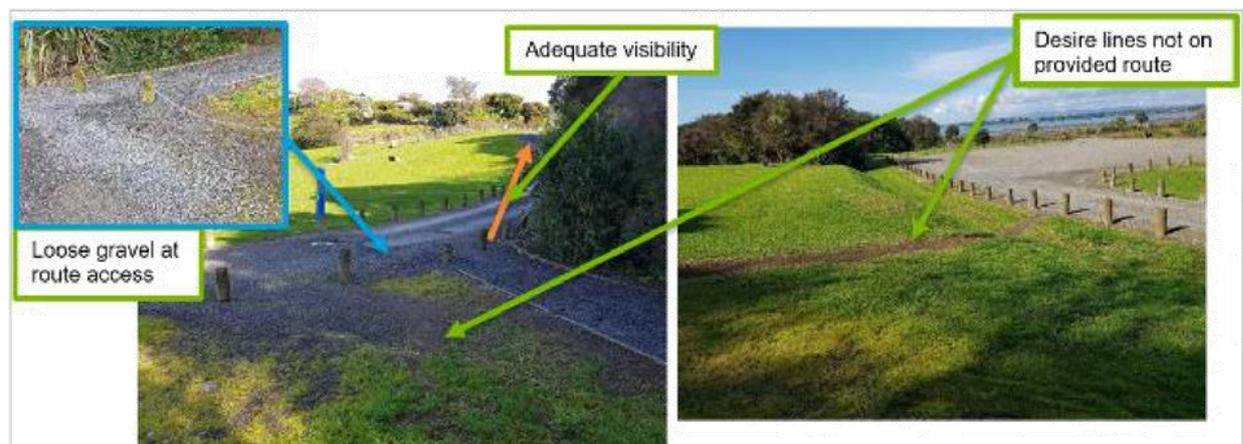
Figure 31: Cooney Reserve access desire line

At the northern access to the route a prominent desire line was observed which is does not align with the metalled route as shown in Figure 31. Cyclists are using two different access points, one of which has a steeper incline as it travels along a small embankment. The desire line avoids the right-angle bend between the cycle path and the car park. The loose surface at the car park access and cycle route will also contribute to users picking an alternative.

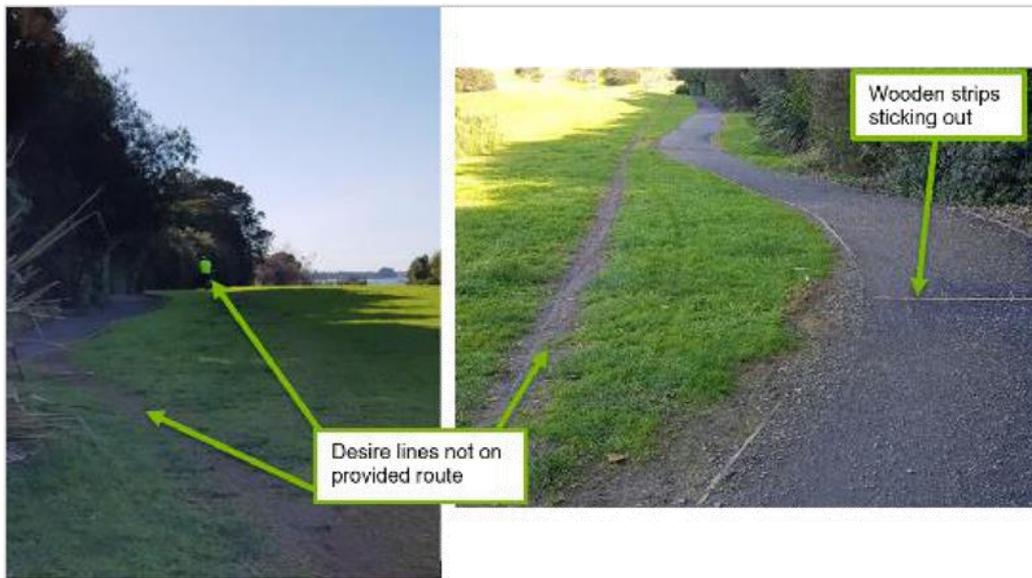
Figure 32: Cooney Reserve desire line next to route and corner cutting

The desire line continues next to the metalled path for approximately 160m to the viewpoint, as shown in Figure 32, and riders are cutting corners along the route between the Cooney Reserve viewpoint and the intersection at Beach Grove.

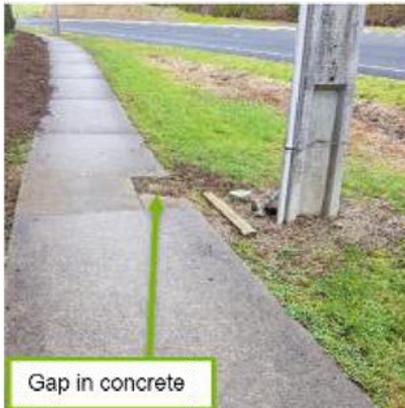
Figure 33: Gap in concrete path - Borell Road

There is a gap in the concrete path on Borell Road as shown in Figure 33. Level differences along the route may cause a cyclist to lose control or pedestrians to trip. This is more likely to occur to new users or inexperienced cyclists such as children.

- Repair the path ensuring the repair is flush with the surrounding concrete.

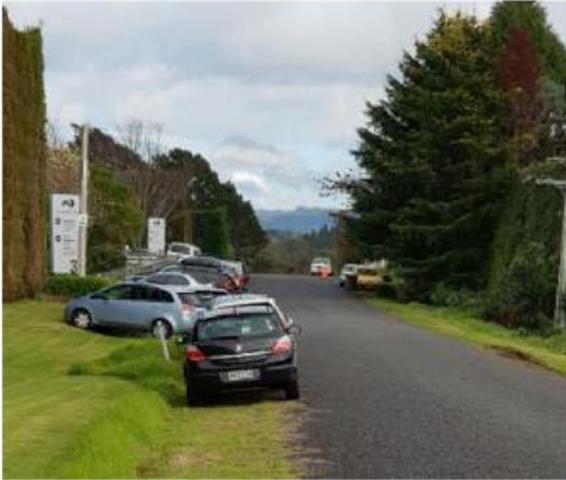
Figure 34: Parallel parked vehicles along edge of Newnham Road

Although some sections are shared road environments, vehicles parked on the side of the road forces cyclists to move further into the carriageway, unnecessarily increasing the risk of a potential vehicle and cyclists' incident. Parked vehicles were present along the shared road environment on Newnham Road as shown in Figure 34. The vehicles parked parallel along the edge of the road limit the visibility of vehicles parked perpendicular along the berm and of vehicles that may be exiting driveways, which increases the risk of drivers not seeing an approaching cyclist when backing from a car park or exiting a driveway.

- Install shared use signs, reduce the speed limit and add sharrows as recommend in 2.1 and 2.15 above.

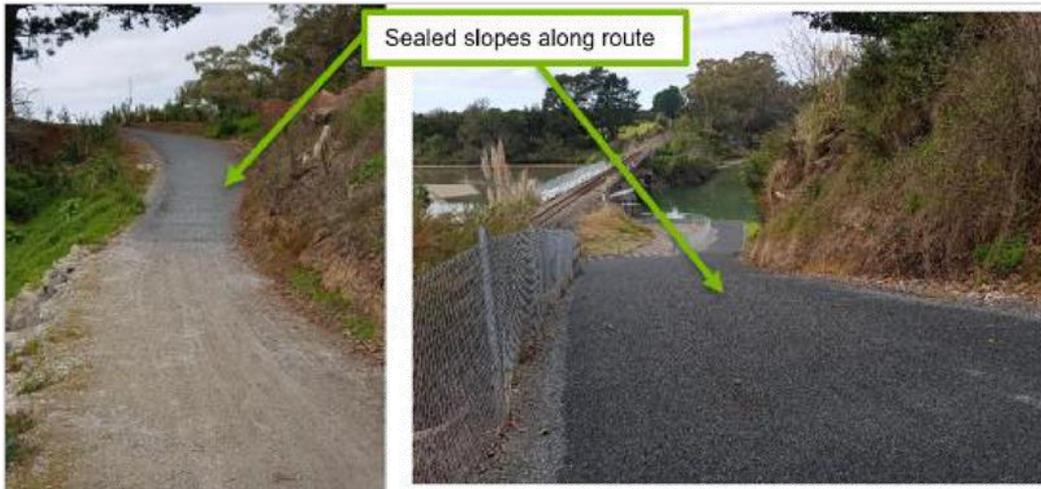
Figure 35: Loose chip on sealed surface at steep slopes

Along the gravel road sections of the route, steep grades have been chip sealed as shown in Figure 35. In most of the cases the sealed surface helps increase skid resistance, allowing cyclists to ascend the steep grade or brake as they descend. Loose chip is still evident on-site and may cause back wheels to skid under braking. This could in loss of control with cyclists falling or not being able to reduce their speed in time.

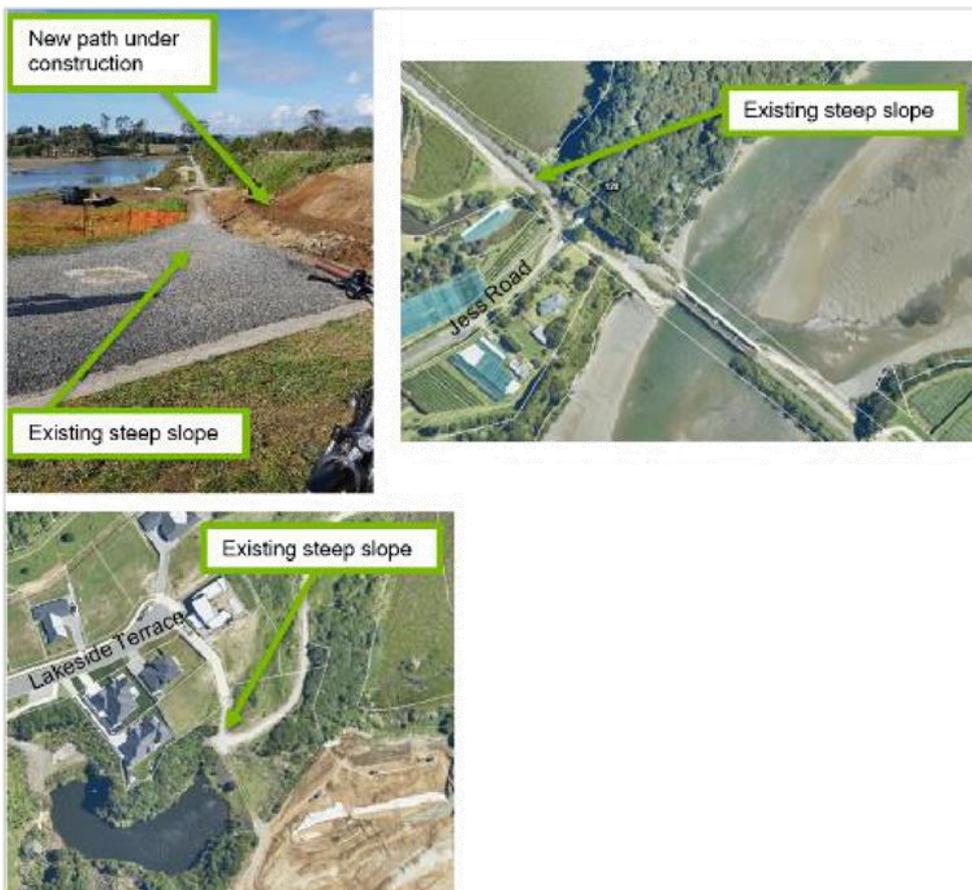
Figure 36: Steep inclines on which cyclists struggled (near Lynley Park Drive, Jess Road and Lakeside Terrace)

At three locations the RSAT noted that cyclists had to either dismount or were struggling to clear the incline, especially without e-bikes. These inclines could result in cyclists toppling over and continuing to travel along the slope until they come to a stop. One of these inclines is being reconstructed, close to Lynley Park Drive as shown in Figure 36.

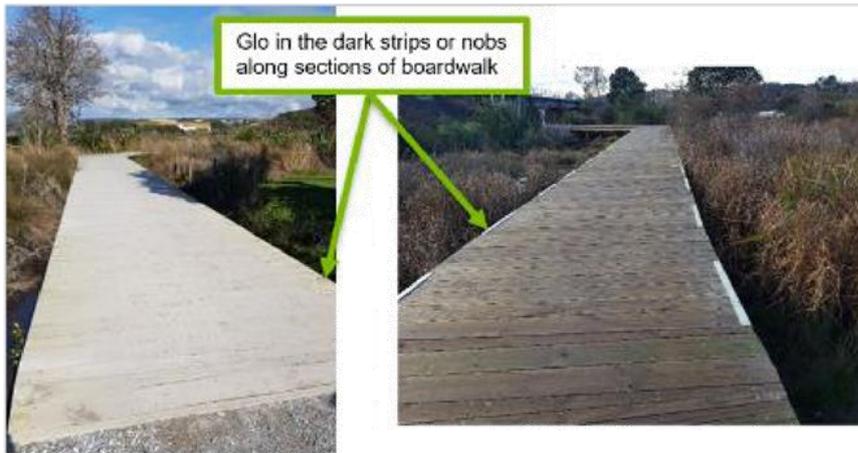
Figure 38: Glow-in-the-dark strips along boardwalks

The boardwalk provides adequate provision for a shared facility especially along the Omokoroa Peninsula. It is expected that the boardwalk will be accessed by residents as a recreational route or for general training activities such as jogging which may occur in the afternoon after work. The boardwalks may not be adequately marked for later afternoon/evening conditions especially during the time of the year when the sun sets earlier in the afternoons as shown in Figure 38. Pedestrians may misjudge the boardwalk width during their activity and step over the edge of the boardwalk which may result in injury.

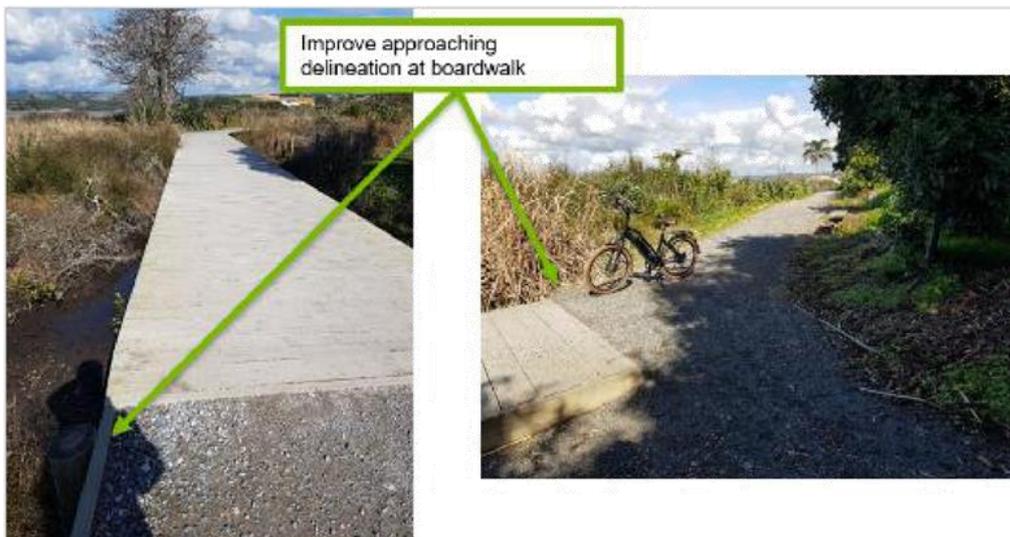
Figure 39: Boardwalk approaches without adequate delineation or warning

On some sections of the boardwalk there is no edge delineation or delineation between the metal surface and the boardwalk and no warning of the height difference between the surfaces which may result in a trip hazard as shown in Figure 39. This could cause pedestrians or cyclists wanting to pass one another to move off the path or misjudge the available space.

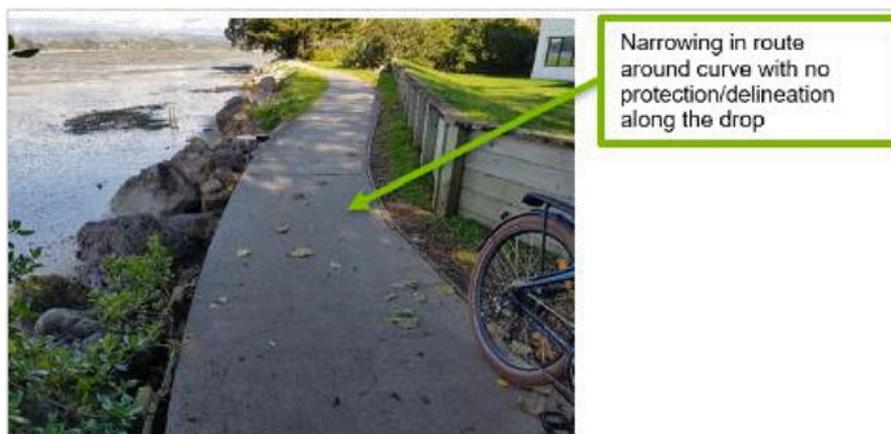
Figure 40: Narrowing on corner of route

The route narrows around a corner with limited visibility of approaching cyclists or pedestrians as shown in Figure 40. The narrow section has a drop onto rocks directly below the edge of the path with no protection or warning, with a risk of users falling onto the rocks if a cyclist swings wide or a pedestrian moves out to make way for an approaching user.

- Provided protection to the drop at the edge of the route;
- Add warning on both approaches highlighting the blind corner.

Frequency Rating:	Infrequent	Severity Rating:	Unlikely
Designer Response:			
WBOPDC Project Manager: Noted and agree with requirement for warning signage. Edge protection not considered necessary.			
Safety Engineer			
Client Decision:			
Warning signage is in place.			
Action taken:

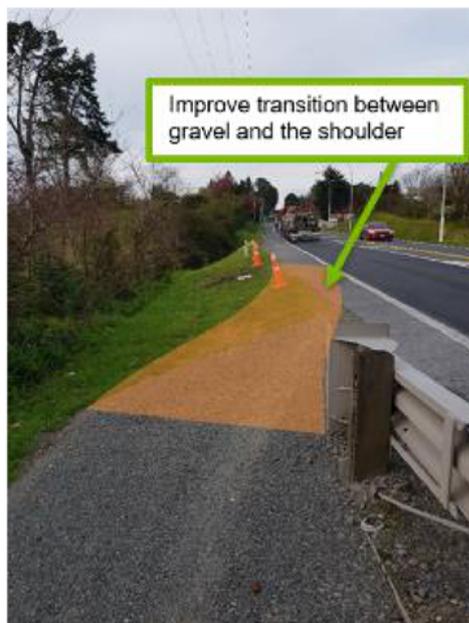
Figure 41: Existing transition from the Wairoa Bridge to the shoulder of SH2

The transition between the existing temporary access between the bridge and the SH 2 is sharp. Cyclists heading towards Bethlehem may pop out surprising drivers. The transition should be eased as indicated in Figure 41. This will allow for a safer transition to and from the shoulder of SH2.
