MEETING – AGENDA –

Performance and Monitoring Committee

9.7 ŌMOKOROA CYCLEWAY SAFETY REPORT

Council has procured a post construction safety audit of the Ōmokoroa to Tauranga Cycleway. The audit team follow a standard procedure to identify risks for users of the service and risks for Council's consideration and where possible, mitigation. The safety audit was a condition of funding.

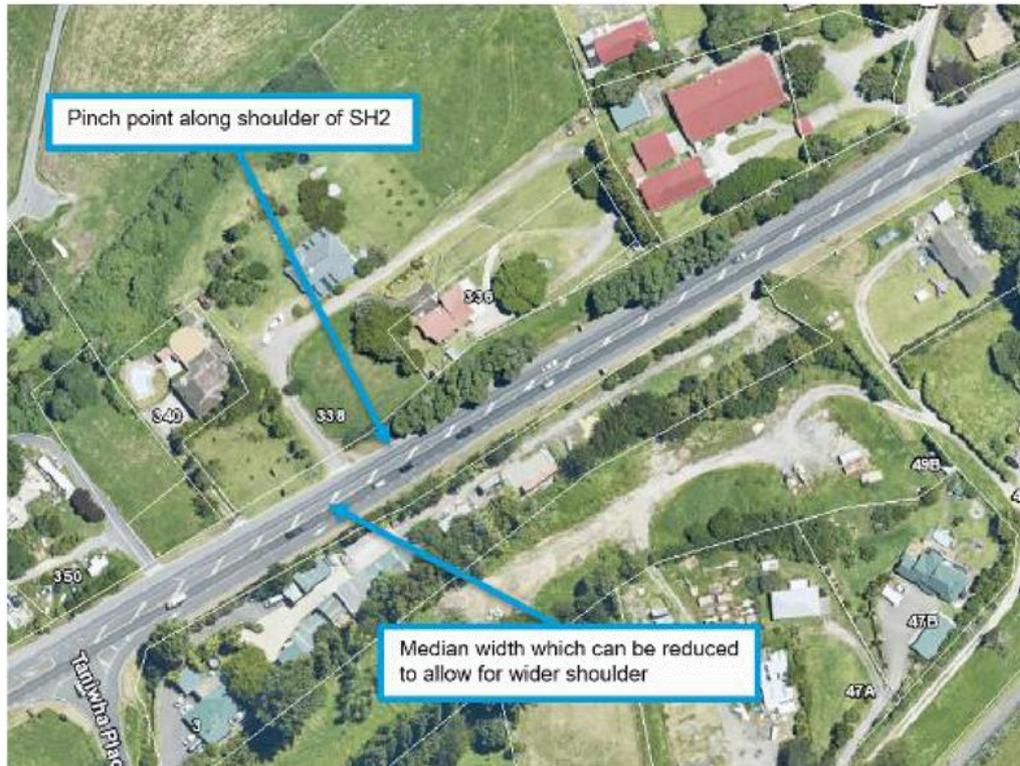
Figure 42: Pinch point along shoulder of SH2

Once the cyclists are on the shoulder of SH2 most of the remaining shoulder width up to the Wairoa Marae entrance will allow sufficient space for single direction cyclist use, except for a short section between SH2 intersections with Taniwha Place and the Wairoa Marae. This section of SH2 contains a painted median which can be reduced to achieve an adequate shoulder width for the temporary use, as shown in Figure 42.

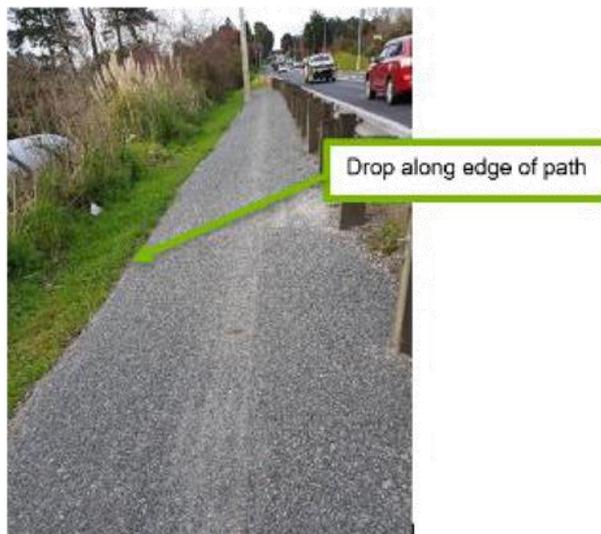
Figure 43: Drop along edge of path between SH2 and Wairoa Bridge

The section of metalled temporary path between the Wairoa Bridge and SH2 rolls off along the edge which could result in cyclists slipping off the edge - refer Figure 43. It is recommended that the edge be supported to maximise the usable width of the temporary path avoiding the hazardous roll-over edge.

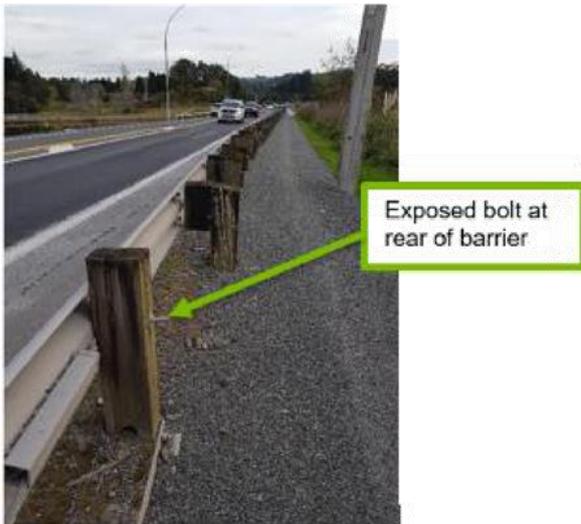
Figure 44: Snagging hazard Wairoa River bridge guardrail

Users may snag the unprotected guardrail bolts that extend beyond the timber supports as shown in Figure 44. There is also a sharp edge on the Wairoa Bridge steel name plate.

- Expedite construction and completion of the designed off-road path connection from the Wairoa Bridge towards Bethlehem.

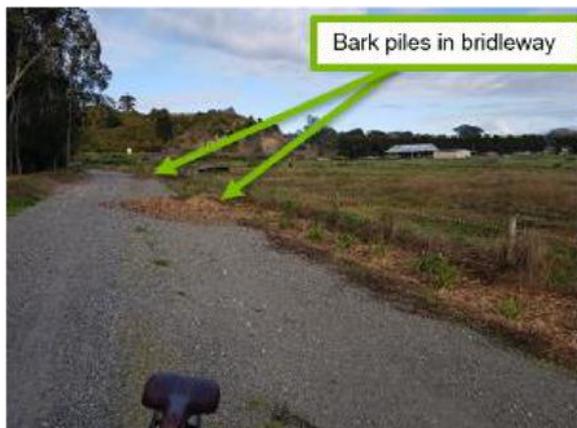
Figure 46: Bridgeway obstructed with bark piles

There were a few piles of bark located along the section near the Pony Club, north of the rail underpass as shown in Figure 46. These piles are obstructing the bridgeway which will force horse riders to use the pedestrian and cyclist section of the shared path. The RSAT understands that these are temporary while landscaping and planting are completed. Ensure that the bridgeway is cleared of the bark piles.

8 March 2021 Update: Obstructing bark piles have been removed.

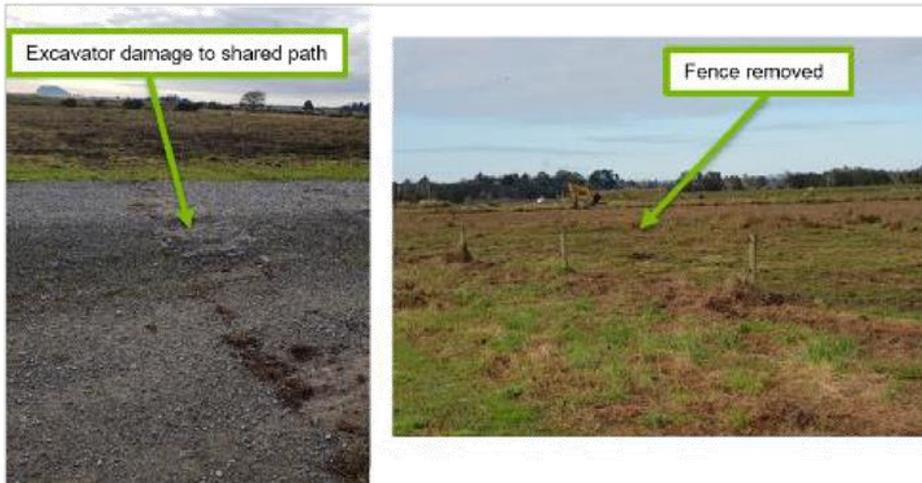
Figure 47: Damaged to shared path and open properties

Along the off-road shared path close to the transition to Lochhead Road, a construction vehicle crossed the shared path damaging the bridgeway and the shared path as shown in Figure 47.

The construction seems to be linked to the wetland rehabilitation works in the area which also removed the fences either side of the cycle route. Discarded fencing materials are lying beside the path. Fencing material should be removed to avoid any potential trip or tangling hazard. The contractor who damaged the path should "make good". There is nothing currently preventing people from wandering over the land adjacent to the cycle way.

8 March 2021 Update: Fence and gates have since been reinstated.

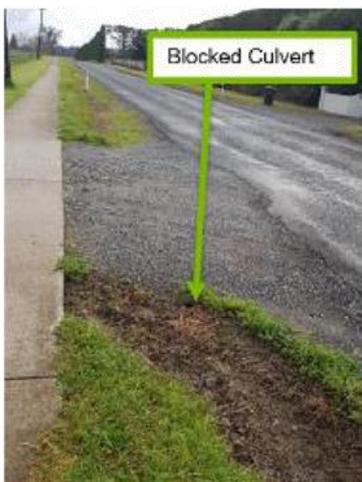
Figure 48: Blocked culverts along Te Puna Road

The culverts under driveways along Te Puna Road are blocked as shown in Figure 48. Stormwater maintenance is required in the area as this poses a localised surface flooding risk.

8 March 2021 Update: Maintenance of entrance culverts is the responsibility of the property owner.

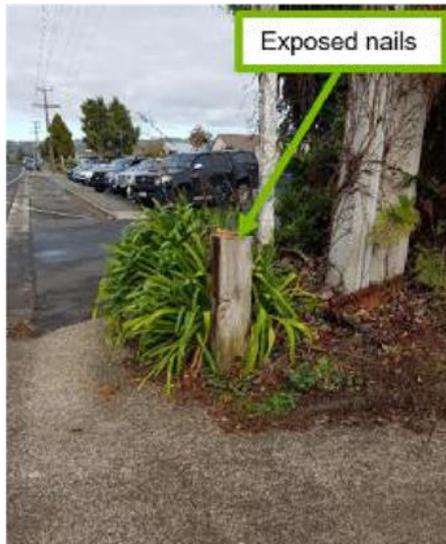
Figure 49: Exposed nails to the north of Te Puna School

A post with exposed nails is situated on Te Puna Road directly north of Te Puna School as shown in Figure 49. This exposed hazard is a risk to school children as well as all users of the cycle route as this is one of the highlighted narrow areas of the route. Remove the exposed nails or the entire post to eliminate the risk of snagging.

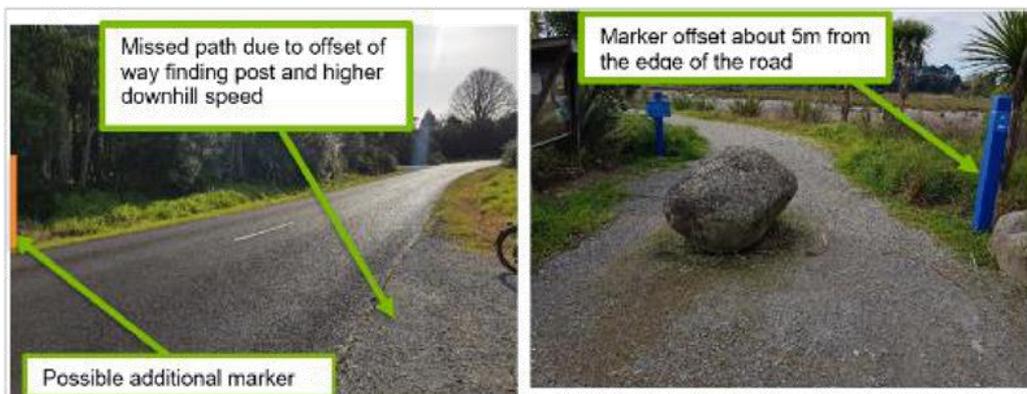
Figure 50: Additional way finding required

At Jess Road, where the turn-off from the shared road environment to an off-road gravel section occurs it is easy to miss the turn. The RSAT missed it. The downhill approach allows for high speeds and the route marker is placed on the left-hand side at the access to the off-road section and is hidden behind a curve. It is suggested that a marker is installed on the opposite side of the road which will make it clear where the off-road section starts as shown in Figure 50. Although not marked at the location shown in Figure 48, users can continue, on Jess Road and re-join the off-road path at the end of Jess Road. At the end of Jess Road there is route marker that directs users onto Jess Road as an alternative to the off-road path. For consistency, Jess Road should be signed for both direction options.

8 March 2021 Update: Roadside vegetation has now been cleared to open up sight lines for both motorists and cyclists.

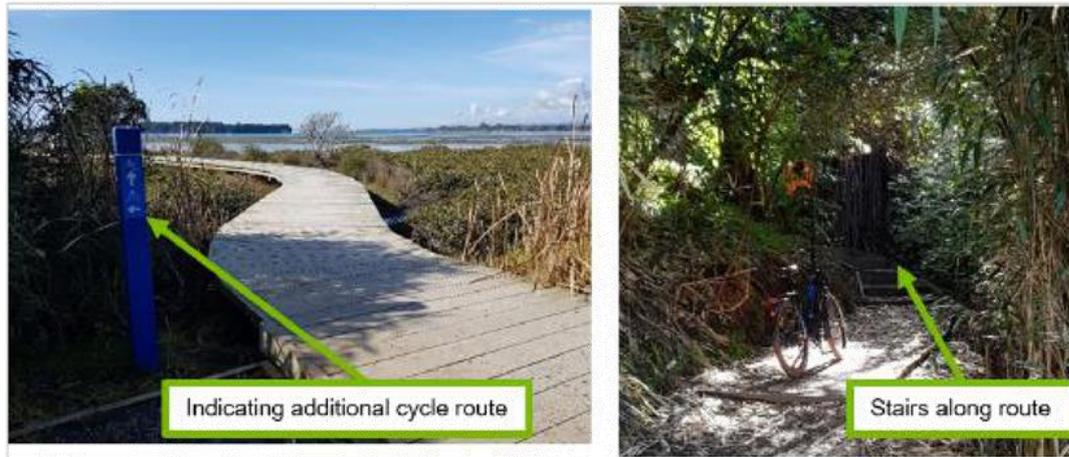
Figure 51: Cycle route marker to stairs

There is a cycle route marker directing users to stairs that climbs to Tinopai Drive. A cyclist will be required to carry the bike up as shown in Figure 51. This cycle symbol should be removed.

8 March 2021 Update: This route is not designed as a cycleway connection.

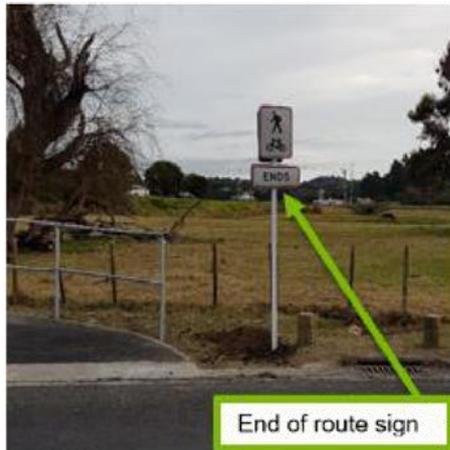
Figure 53: Start and end at Wairoa River Bridge

The end of route sign is misleading at the Wairoa Bridge with the route ending and beginning at the access to the bridge which forms part of the route as shown in Figure 53. The end of the route at Omokoroa Boat Club does not clearly indicate the end or beginning of the route as shown in Figure 54. The Omokoroa end/start could also have a destination board which directs to local recreational activities and points of interest, in the immediate area, such as the café, the ferry, Omokoroa Domain, Gerald Crapp Historic Reserve and Wai Huri Pa.

The safety audit assessed the Omokoroa to Tauranga route as this is the section with Waka Kotahi funding. The cycling routes continue at each end as part of an integrated network and accordingly, specific start and end route signage may not be required. Additional route maps showing other routes could be more beneficial.

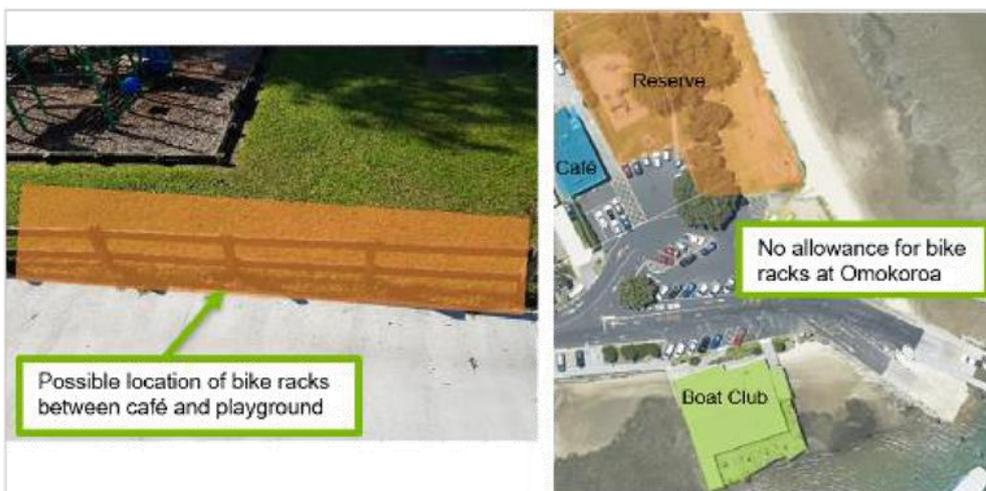
Figure 56: Existing area where cyclists leave their bikes

There are no facilities for cyclists to park their bikes while they either explore the surrounding area or when they visit the café or boat club. Café staff highlighted an area where cyclists place their bikes when they visit the café as shown in Figure 56. Staff also mentioned that it is a very common question asked by all the cyclists visiting the café. They also mentioned that there could be up to 20 bikes parked outside the café over weekends.

8 March 2021 Update: New bike racks have been installed and more will be installed as part of the playground project.

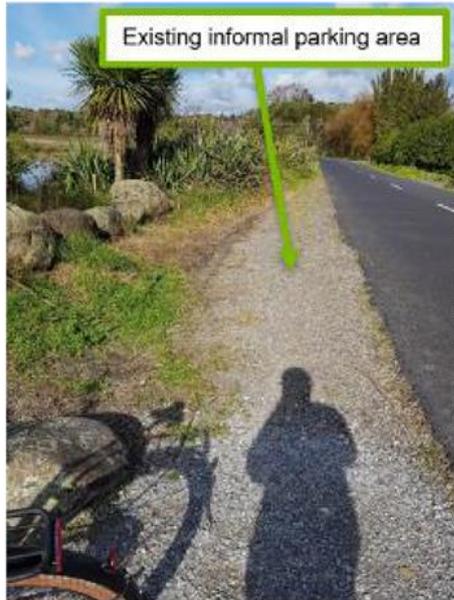
Figure 57: Potential demand for an additional parking area

A member of the community highlighted a section next to Jess Road which recreational users use to park their vehicle to access the route as shown in Figure 57. The informal parking area may become too small for recreational users if demand increases. Council should consider future extension of the shoulder parking area.

8 March 2021 Update: Disagree as it is contrary to staff view that parking should not be encouraged along this section. Note previous comment that vegetation clearing has now improved sight line issues.

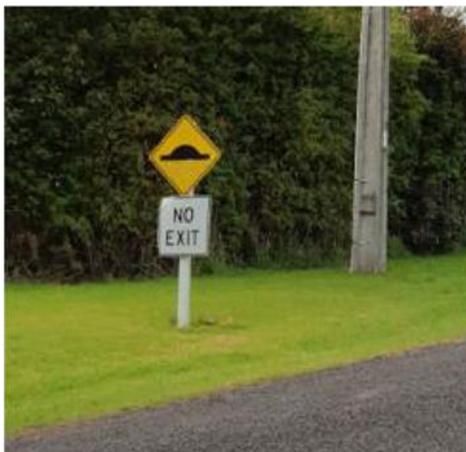
Figure 58: Existing Speed hump warning sign (PW-39)

There is a speed hump (PW-39) sign on Lochhead Road to the southeast of the intersection between Lochhead Road and Oikimoke Road with no physical speedhump along the road as shown in Figure 58. Remove the sign as it is irrelevant.

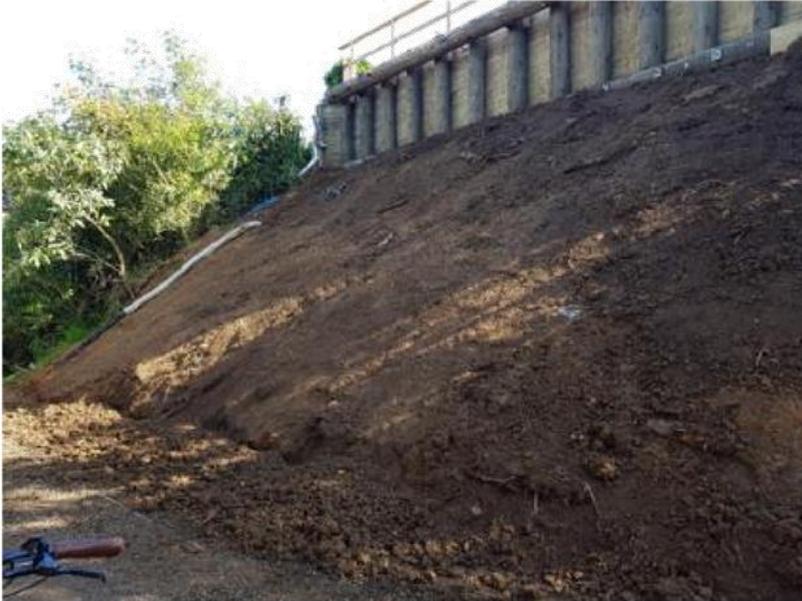
Figure 59: Existing slope which requires protection to avoid erosions and debris affecting the cycle path below

A private property adjacent to the shared path between Beach Grove and The Esplanade has a recently constructed retaining wall and a steep slope above the off-road path as shown in Figure 59. Works are incomplete and the slope requires work to maintain a stable finish.

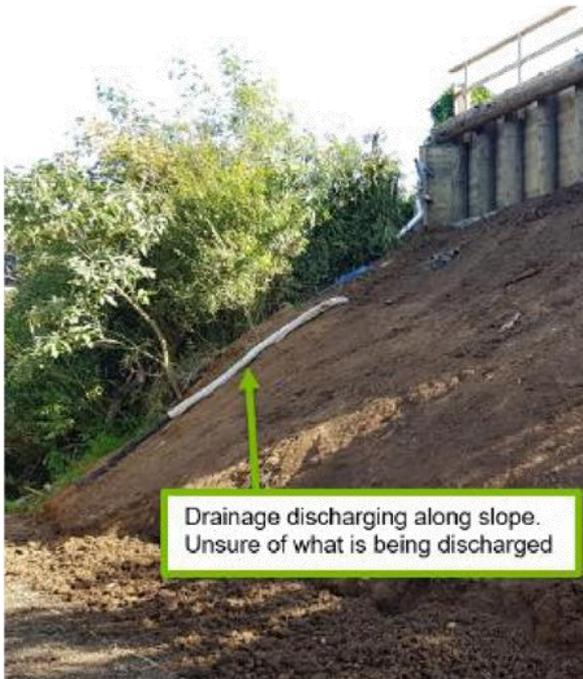
Figure 60: Existing drainage pipe on slope

The slope also contains a protruding pipe, which is assumed to be subsoil drainage but could be for stormwater discharge as shown in Figure 60. At the time of the safety audit there was no erosion control in place. Ensure that all works are completed satisfactorily to avoid future erosions and stability issues. This section of Omokoroa has a history of instability.

8/3/2021 Update: The bank toe debris has been cleared and works have been programmed to complete the retaining to the required specification.
